NPS-56-80-006

COMBAT DAMAGE ASSESSMENT TEAM
A-10/GAU-8 LOW ANGLE FIRINGS
VERSUS
SIMULATED SOVIET TANK COMPANY (ARRAY 20)
(AEROJET LOT NUMBER AJD 79A181-001)
(19 SEPTEMBER 1979)
R.H.S. STOLFI
R.R. McEACHIN

MAY 1980

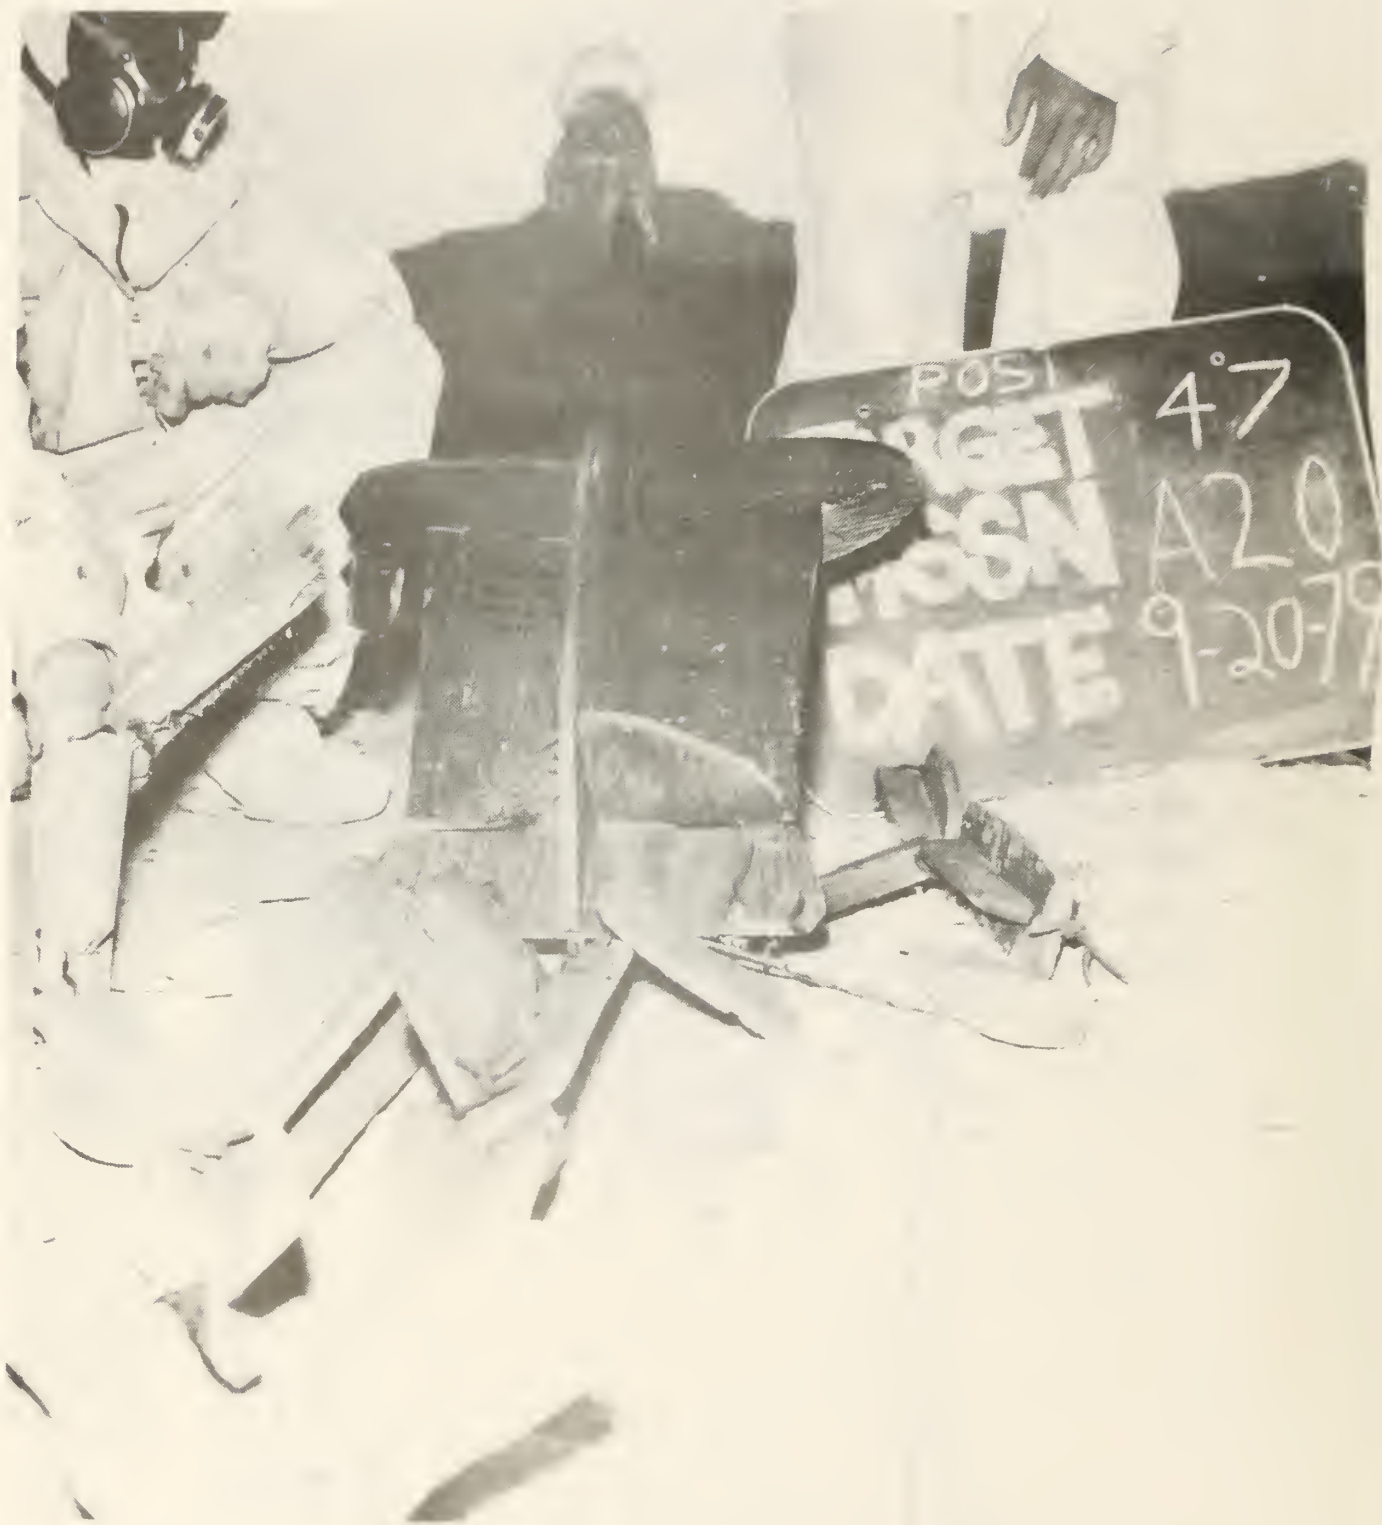
- a. M-Kill: The assessment of 100% M-Kill was based on impacts 7, 8, and 10 which perforated the left side of the turret killing the commander (Figure 8) and gunner and wounding the loader, driver, and bow gunner (Figure 9), impact 19 which destroyed the left number 1 road wheel hub, and impacts 13, 14, 15, 24, and 25 (Figure 10) which cumulatively damaged the track and suspension system.
- b. F-Kill: The assessment of 100% F-Kill is based on crew casualties to all five crew members.

FIGURE 8. Fragment Damage to Commander Manikin from Impacts 7, 8, and 10, Tank 47.

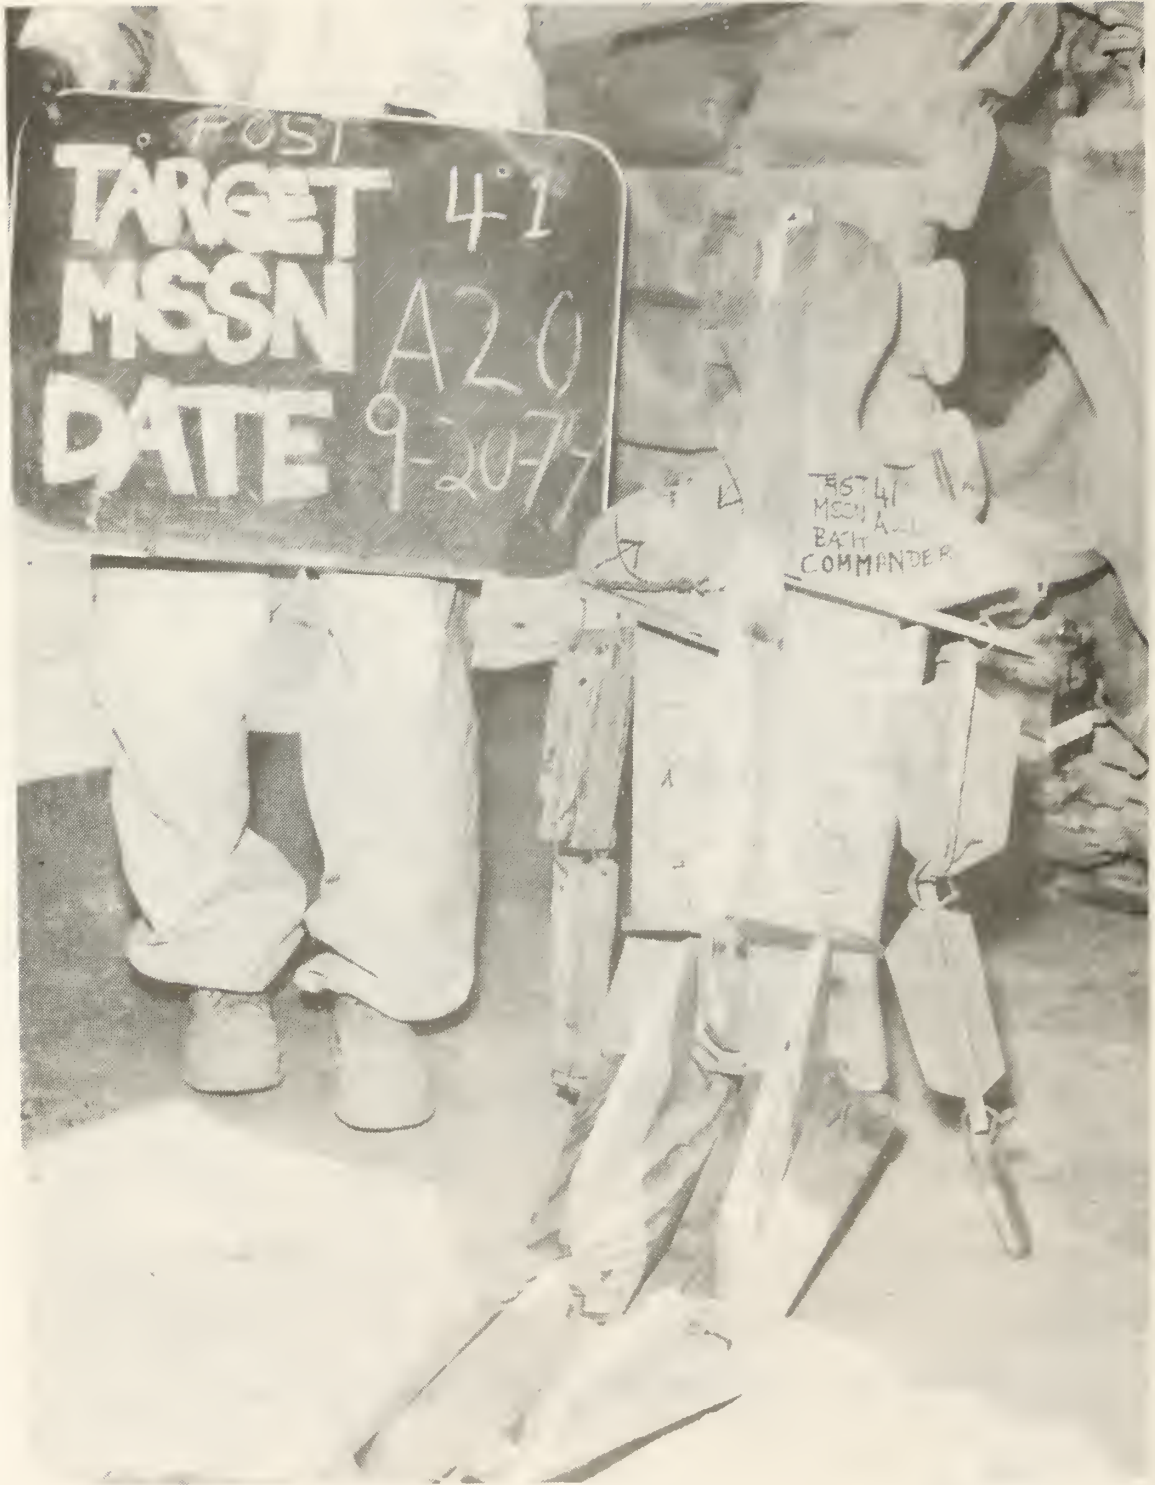
- a. M-Kill: The assessment of a 100% M-Kill is based on impact 29 which perforated the left hull armor and penetrated the fuel tank; to impact 8 (Figure 17) which wounded all personnel in the fighting compartment; and to cumulative damage to the track and suspension system resulting from impacts 13, 15, 20, 22, and 33 (see Figure 18 for impacts 13, 20, and 22).
- b. F-Kill: The assessment of 100% F-Kill is based on impacts 9, 10, and 11, which jammed the turret and prevented it from traversing (Figure 19); and impact 8 which incapacitated the tank commander, gunner and loader.

FIGURE 17. Wounds Sustained by Tank Commander Manikin, Tank 41.

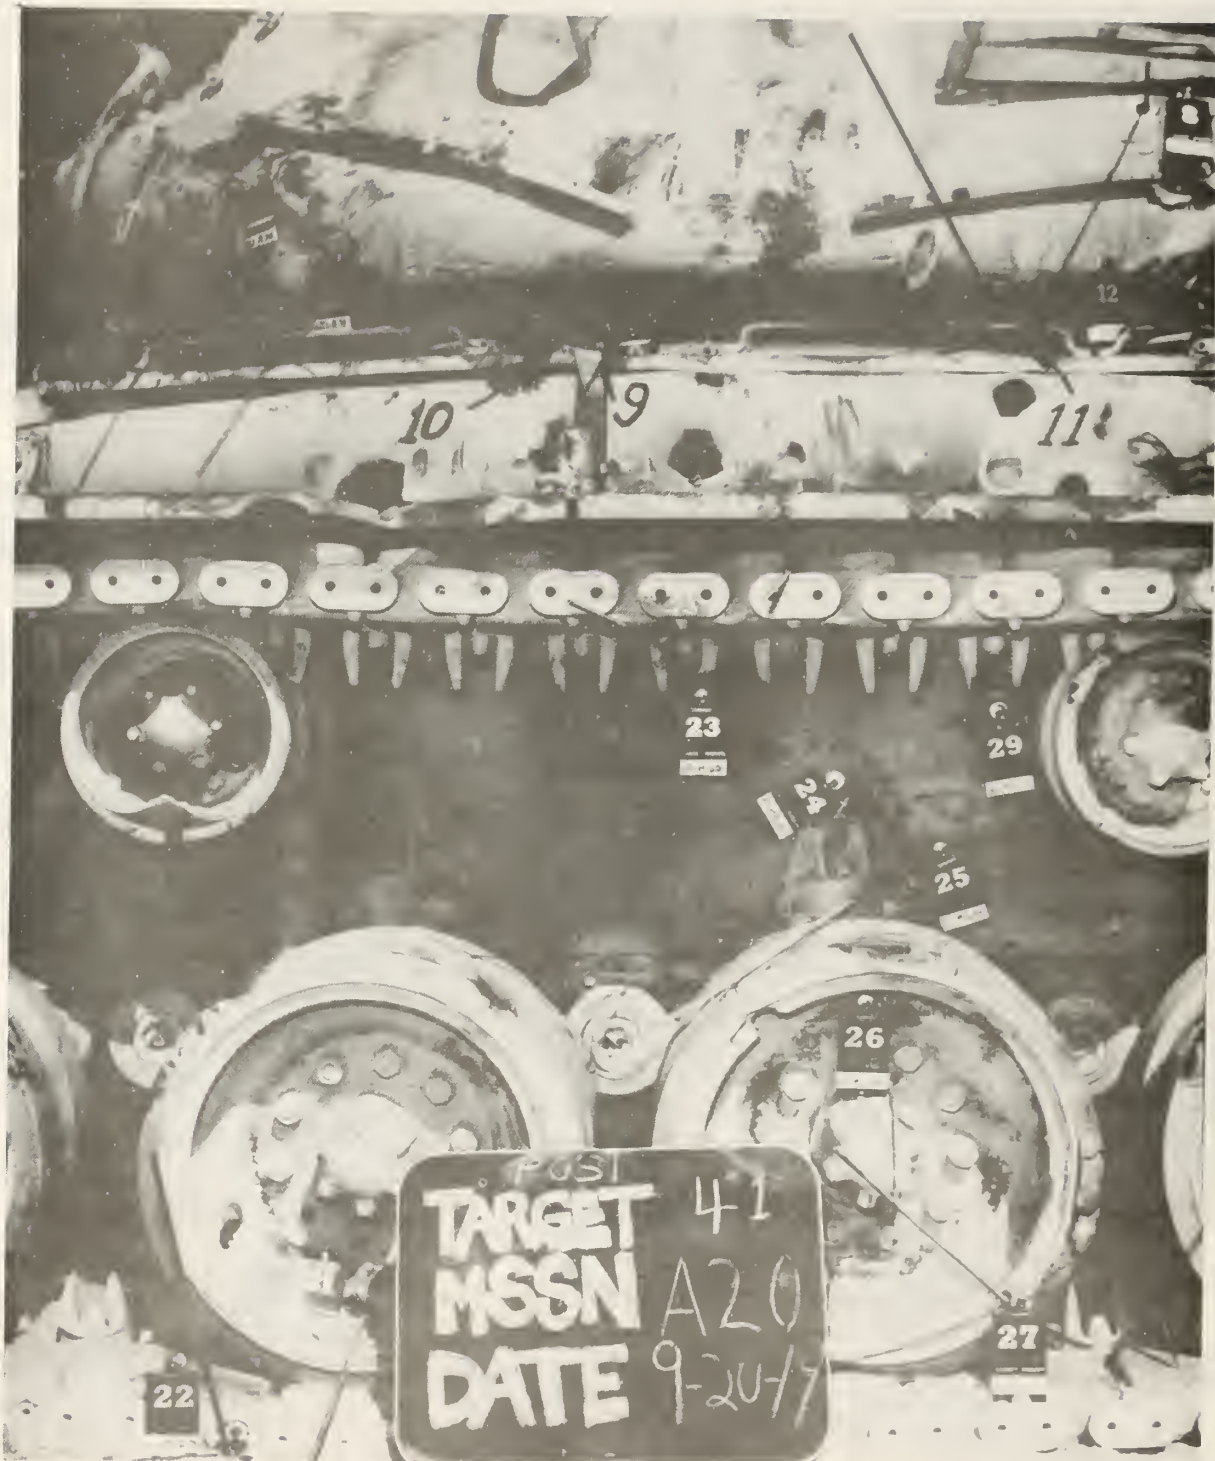
FIGURE 19. Jammed Turret caused by Impacts 9, 10, and 11, Tank 41.

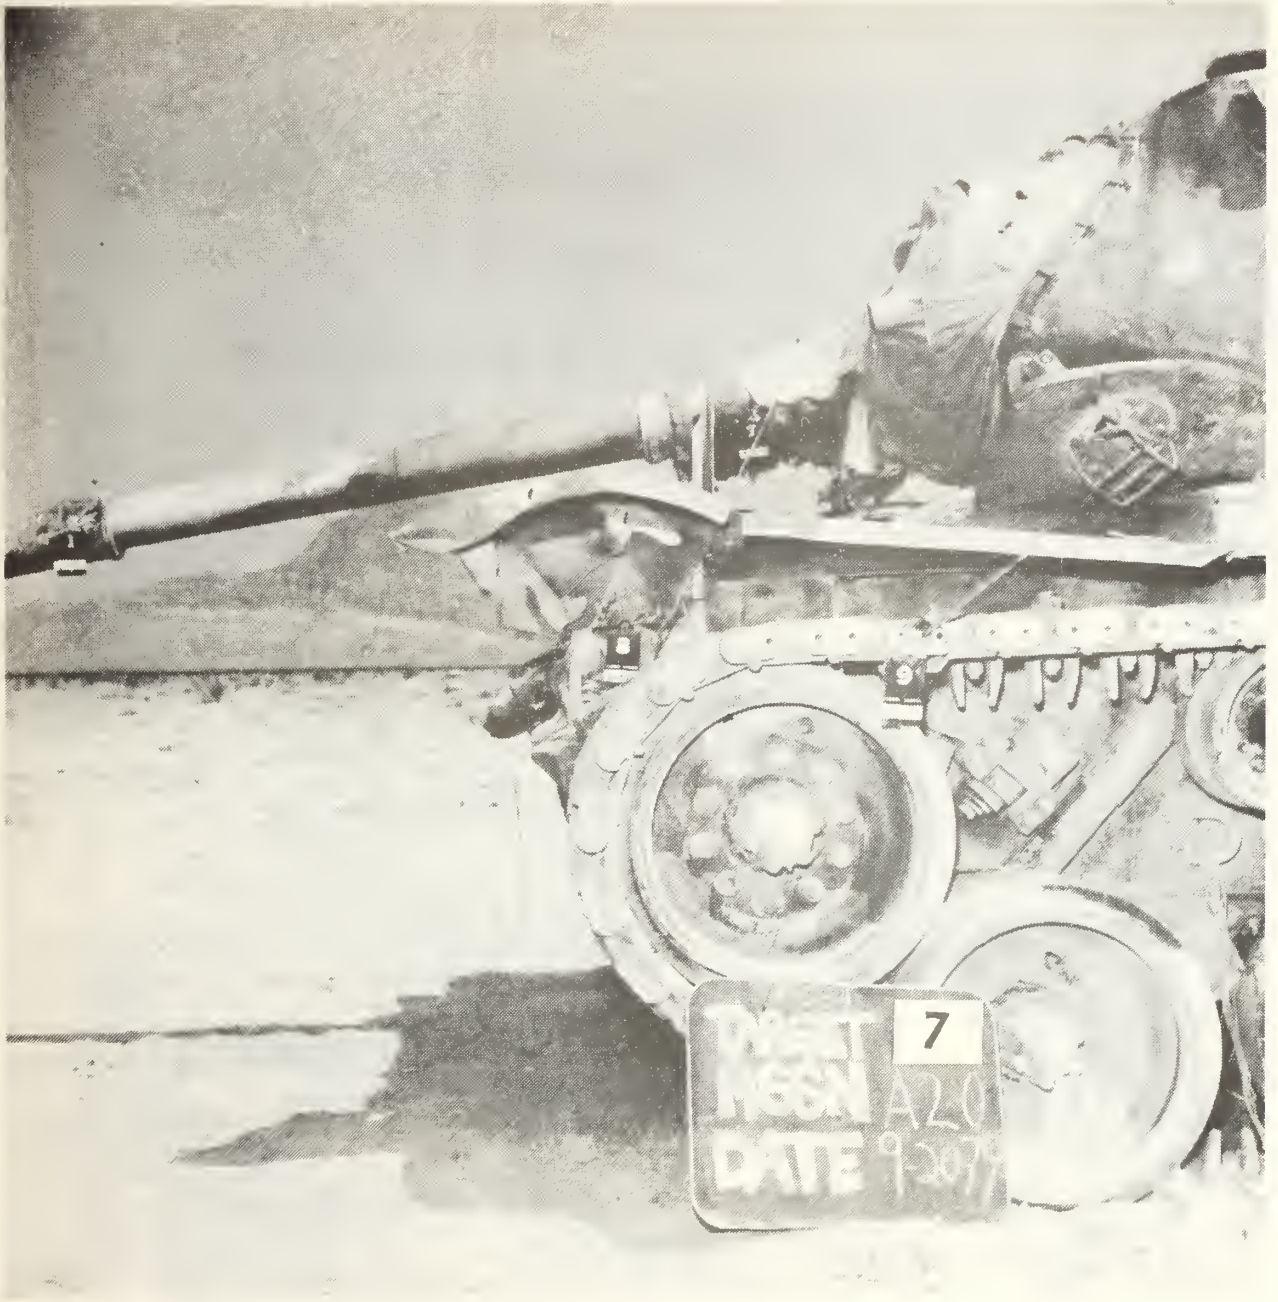
- a. M-Kill: The assessment of a 100% interdiction type M-Kill after 500 meters movement was attributed to impact 9 (Figure 21) which destroyed one end connector and one track center guide on the same pair of track links, and to cumulative damage to the track and suspension system caused by impacts 25, 26, 27, 29, (Figure 22) and six other impacts.
- b. F-Kill: A 20% F-Kill was assessed due to damage caused by impact 1, (Figure 20 and 21), which penetrated the bore evacuator and gun tube.

FIGURE 21. Damage to Track Connector and Center Guide Caused by Impact 9; Tank 7.

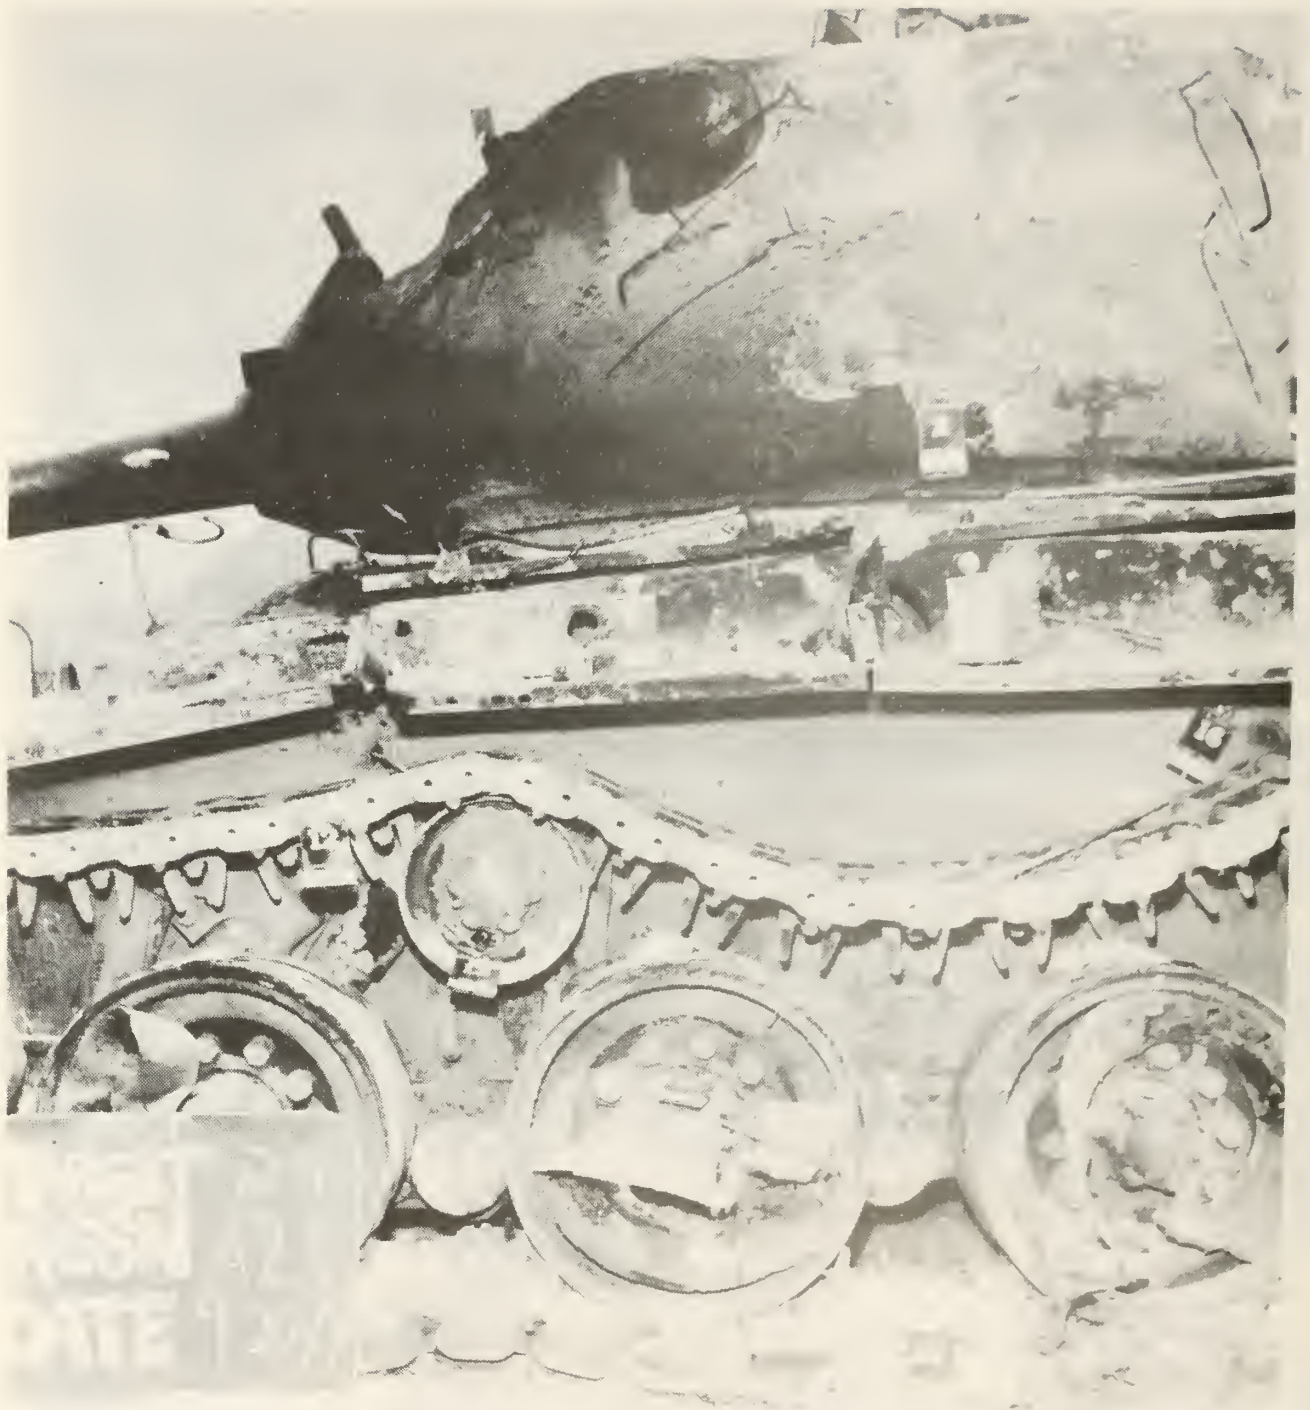
FIGURE 28. Perforations 2, 4, 8, and 12 which Incapacitated the Crew, Tank 29.

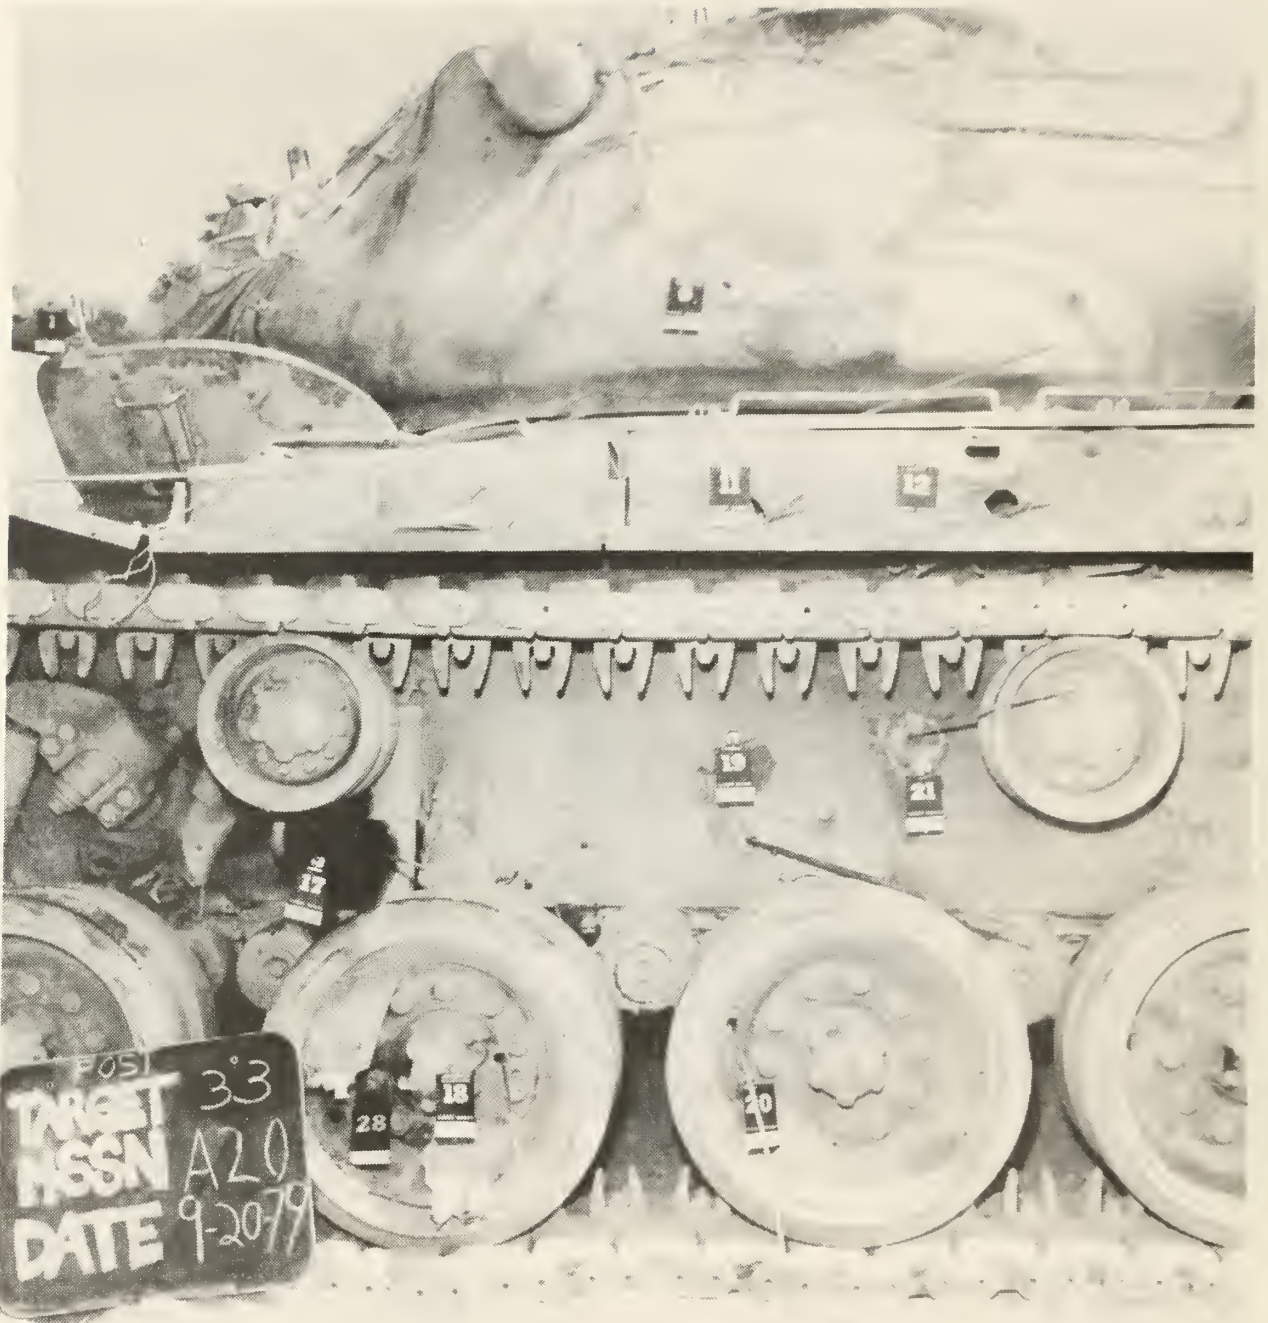
- a. M-Kill: A mobility degradation of 10% was assessed due to minor track and suspension damage caused by impacts 14 and 22
- b. F-Kill: A firepower degradation of 30% was assessed due to loader casualty (Figure 31) caused by impact 6 (Figure 32).

FIGURE 31. Impact 6 which Perforated the Turret and caused Loader Casualty, Tank 33.

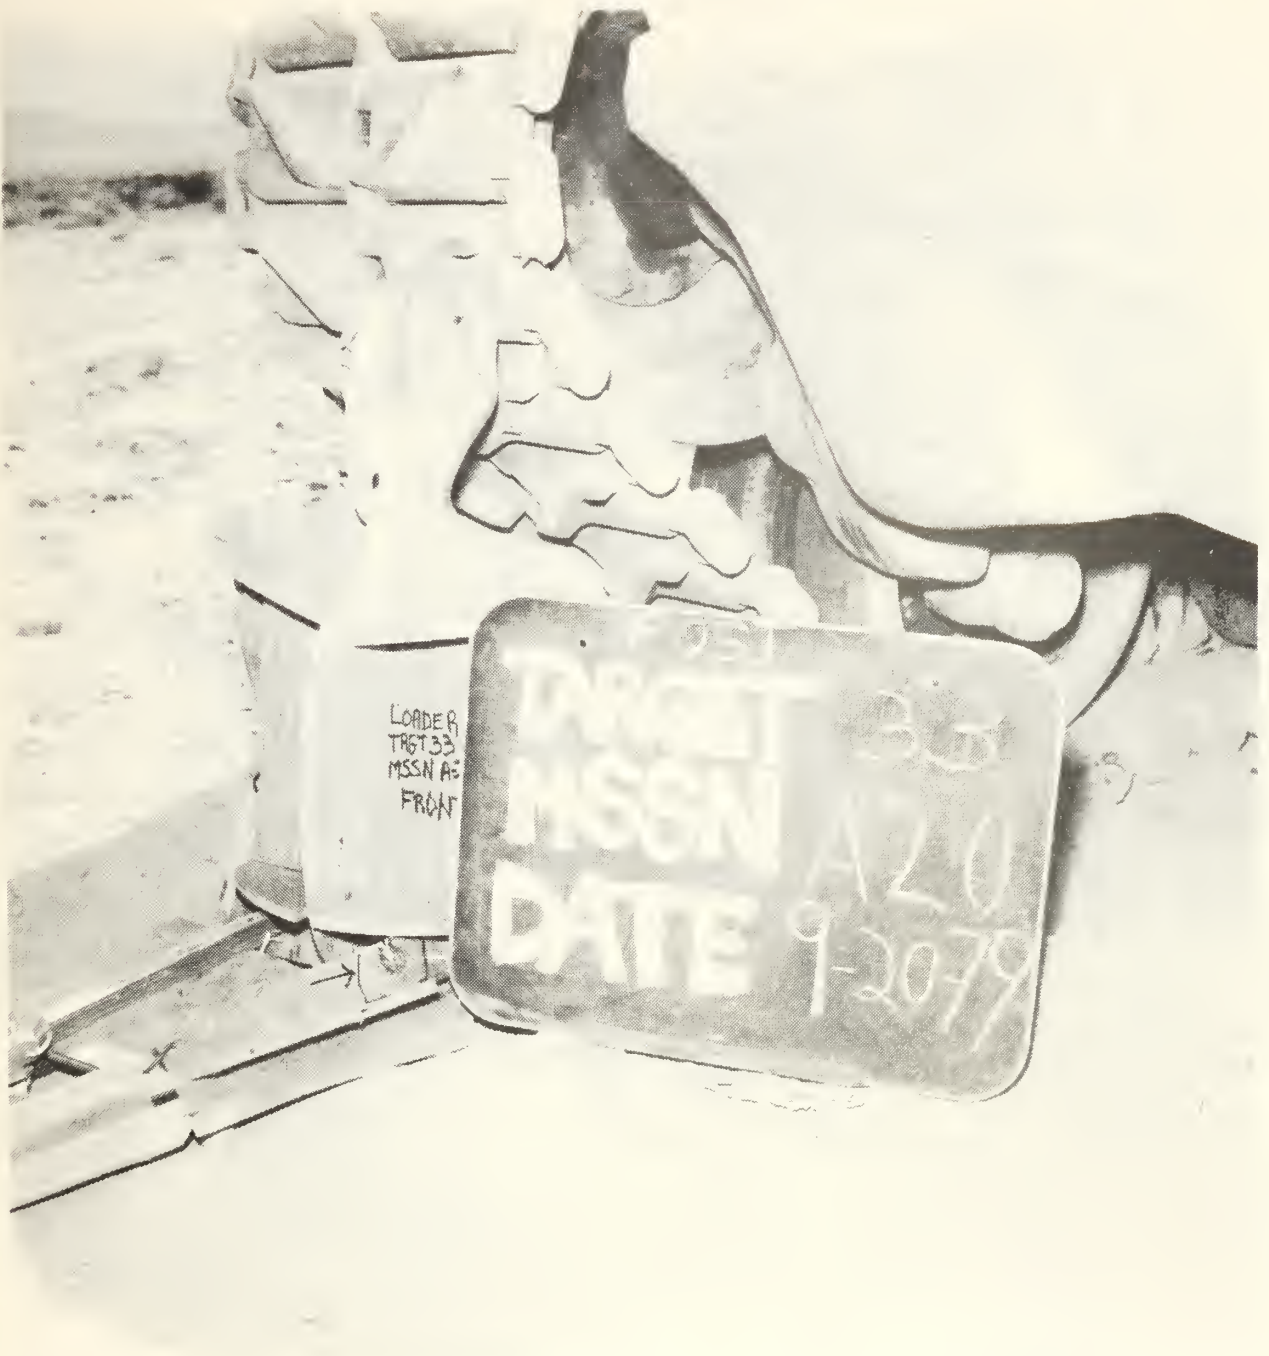
FIGURE 32. Damage to Loader Manikin (arrow) caused by Impact 6; Tank 33.

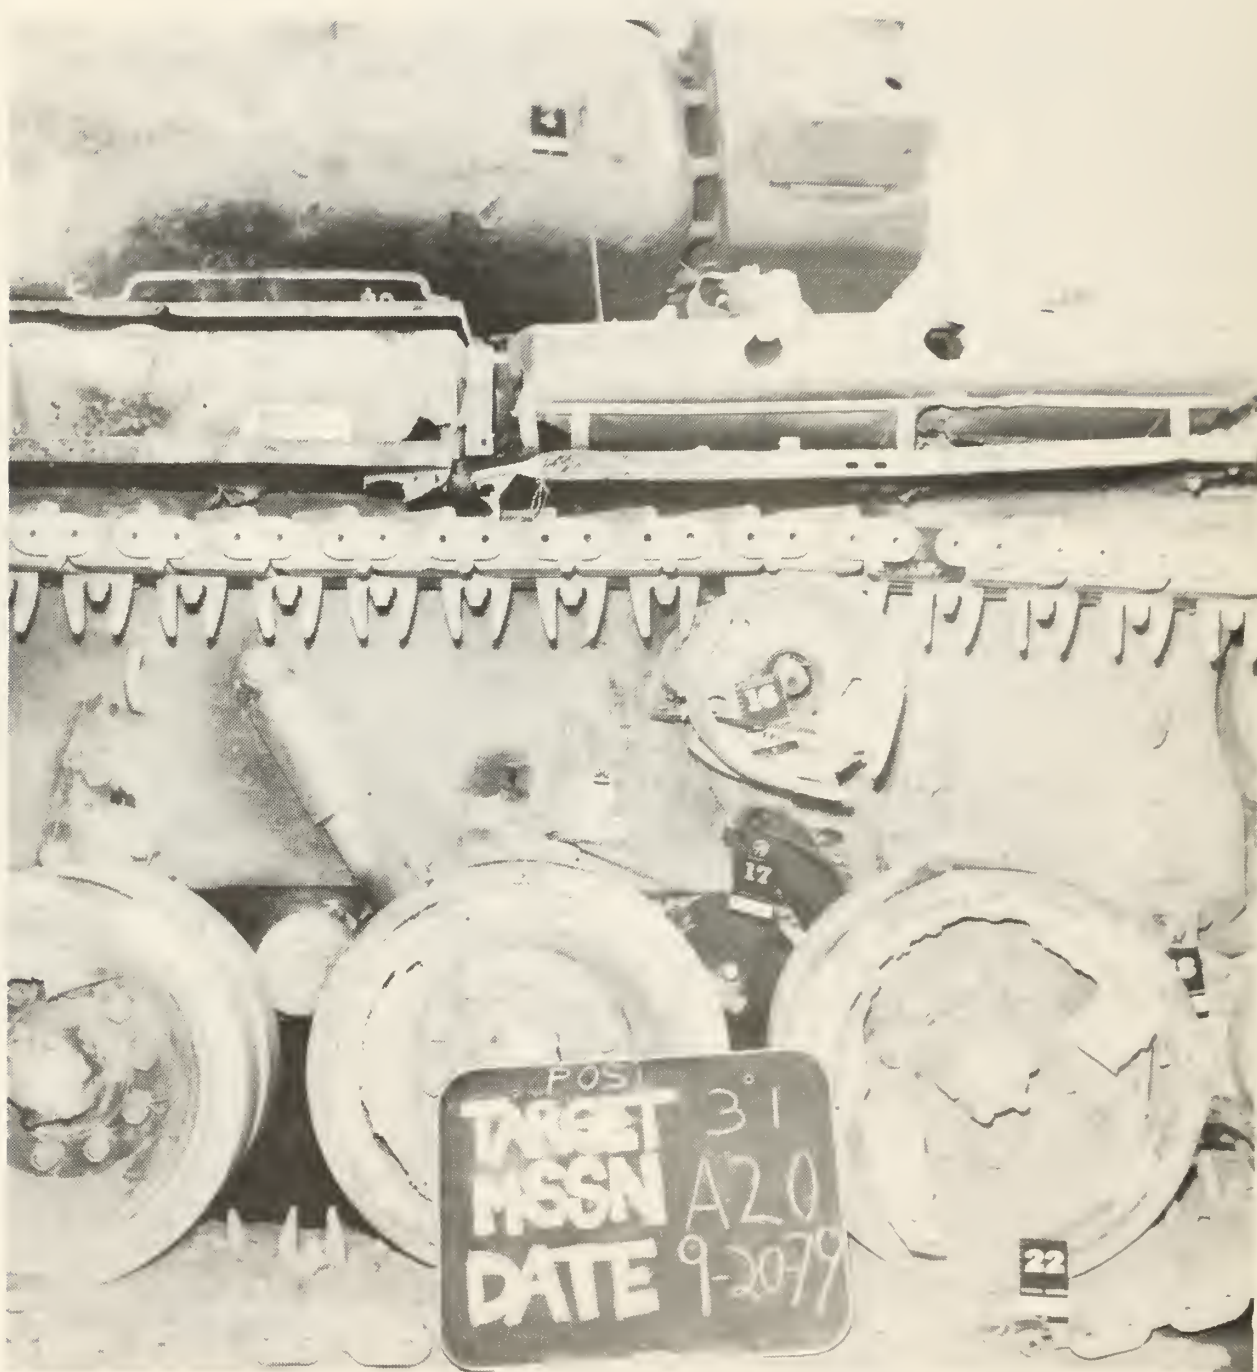
- a. M-Kill: The assessment of a 100% M-Kill is based on impact 17 (Figure 34) which perforated the left hull and penetrated the fuel tank, and on track and suspension damage resulting from impacts 16, 19, and 22.
- b. F-Kill: The assessment of a 95% F-Kill is based on assessed casualties to crew members in the fighting compartment (Figures 35, 36, and 37) caused by impact 2.

FIGURE 34. Impact 17, Perforation of Hull and Fuel Tank, Tank 31.

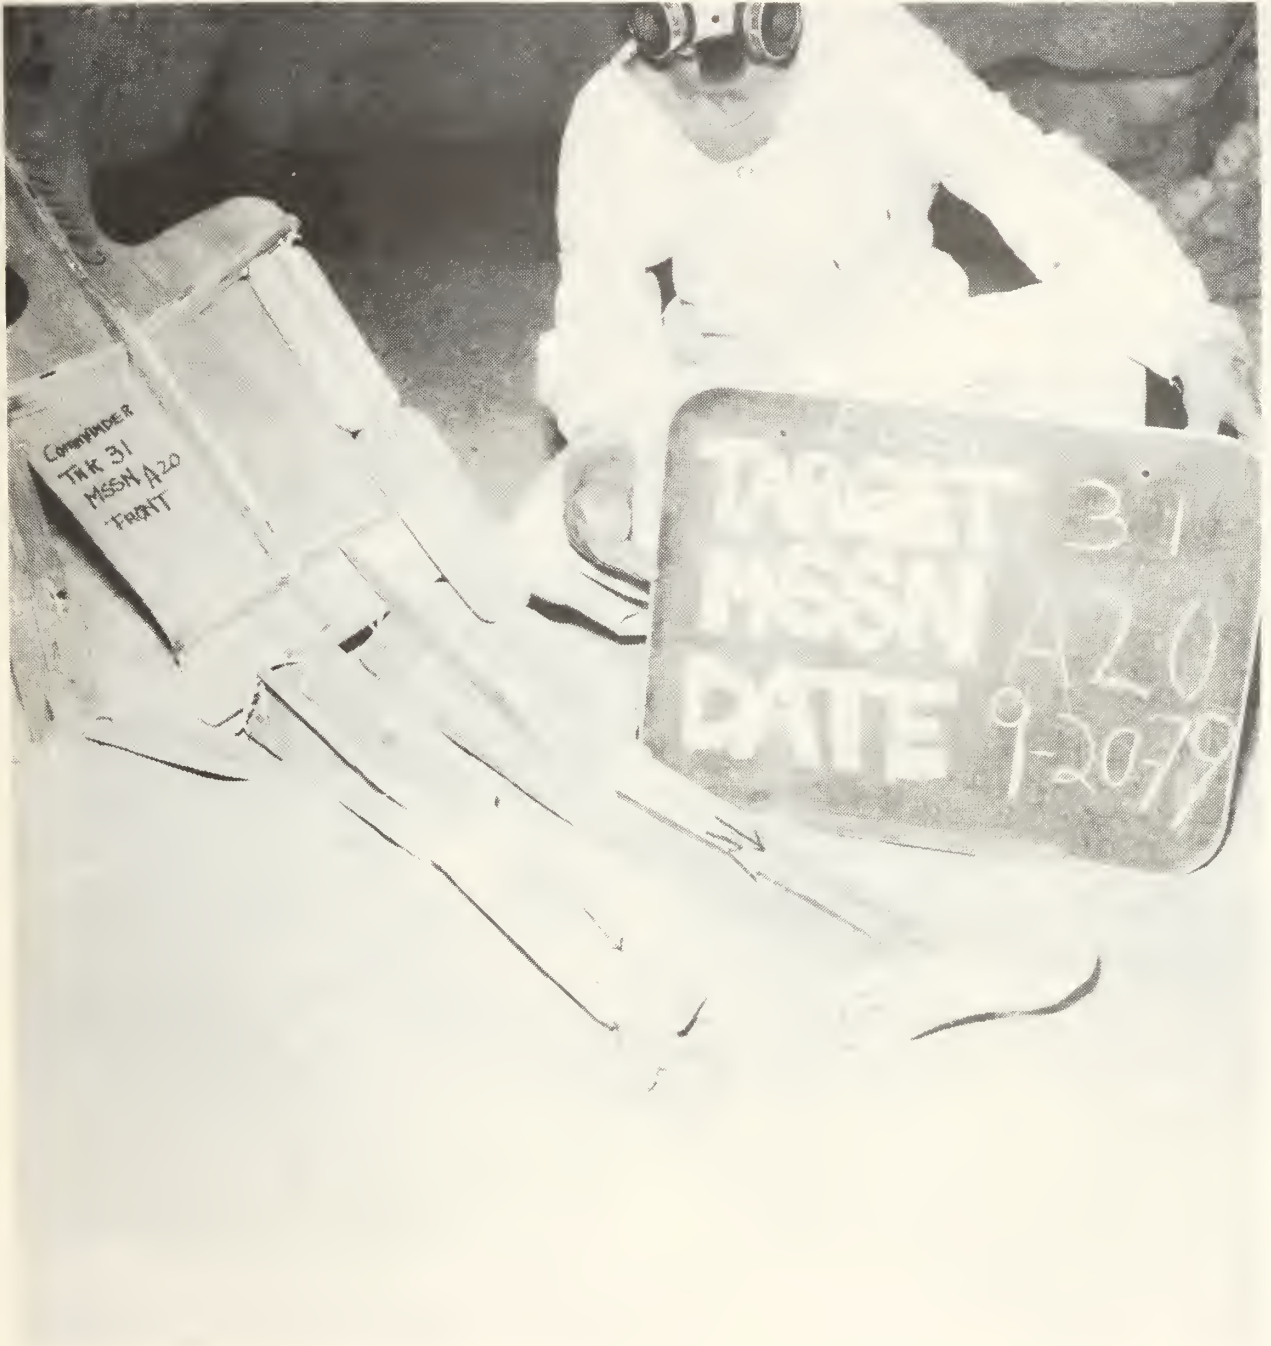
FIGURE 35. Damage to Commander Manikin caused by Impact 2, Tank 31.

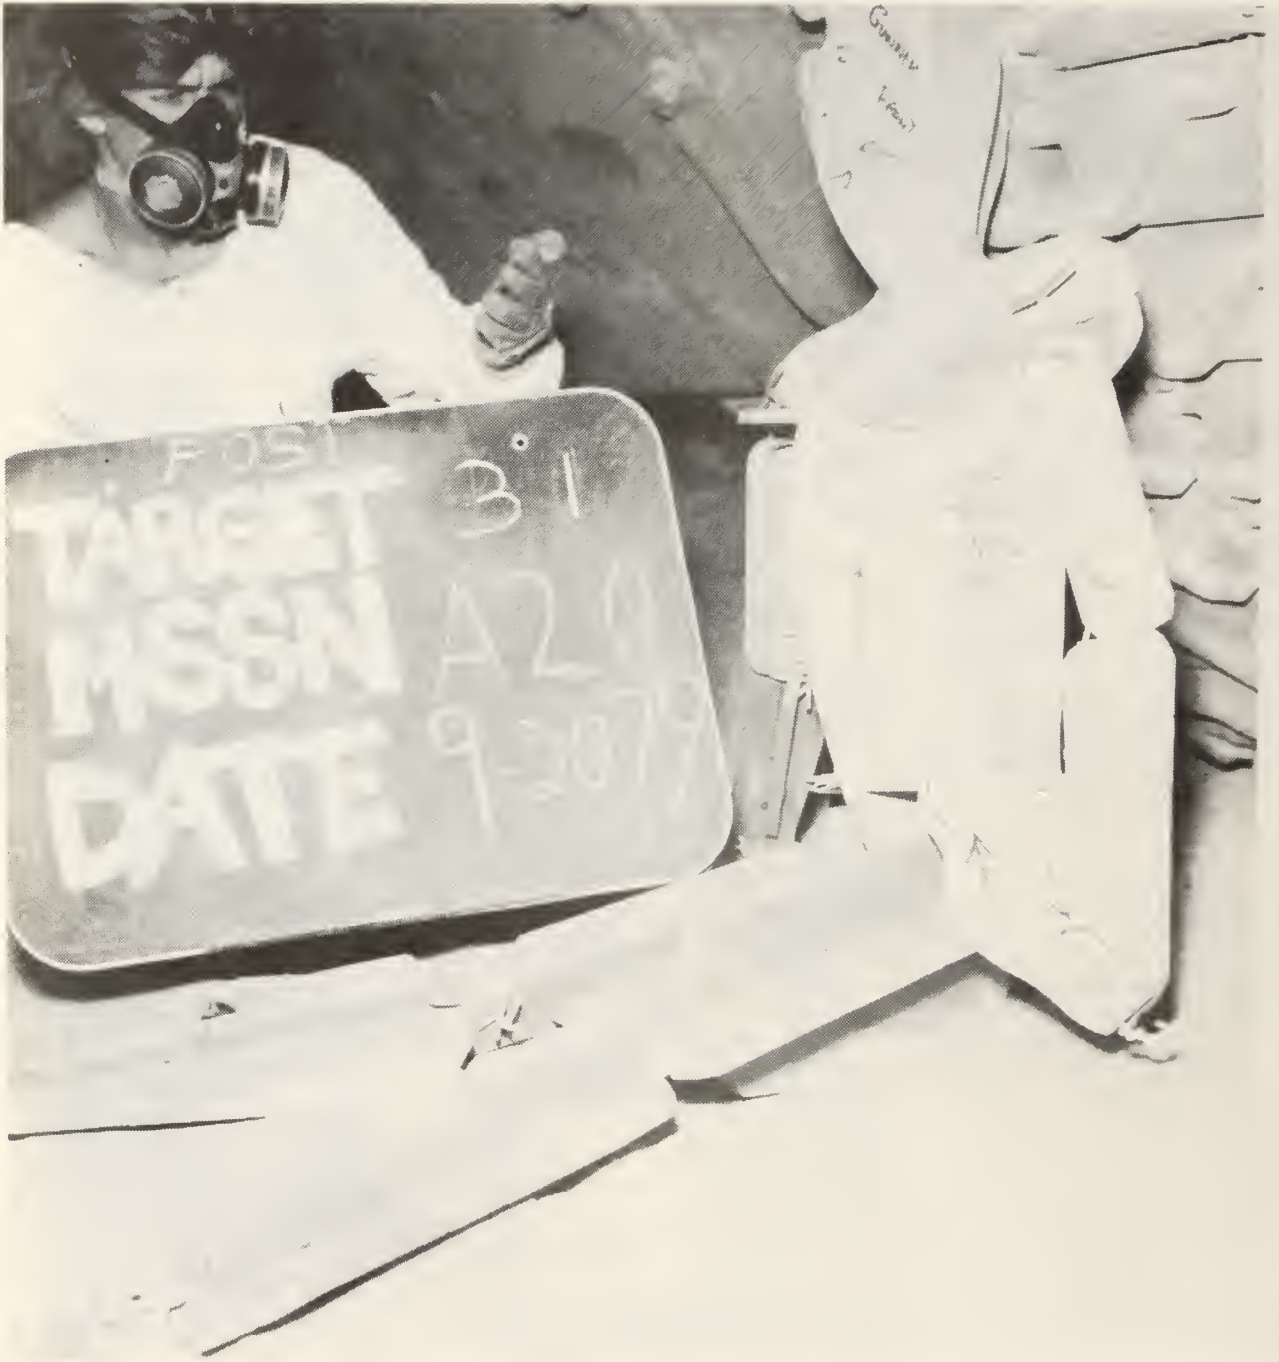
FIGURE 36. Damage to Gunner Manikin caused by Impact 2, Tank 31.

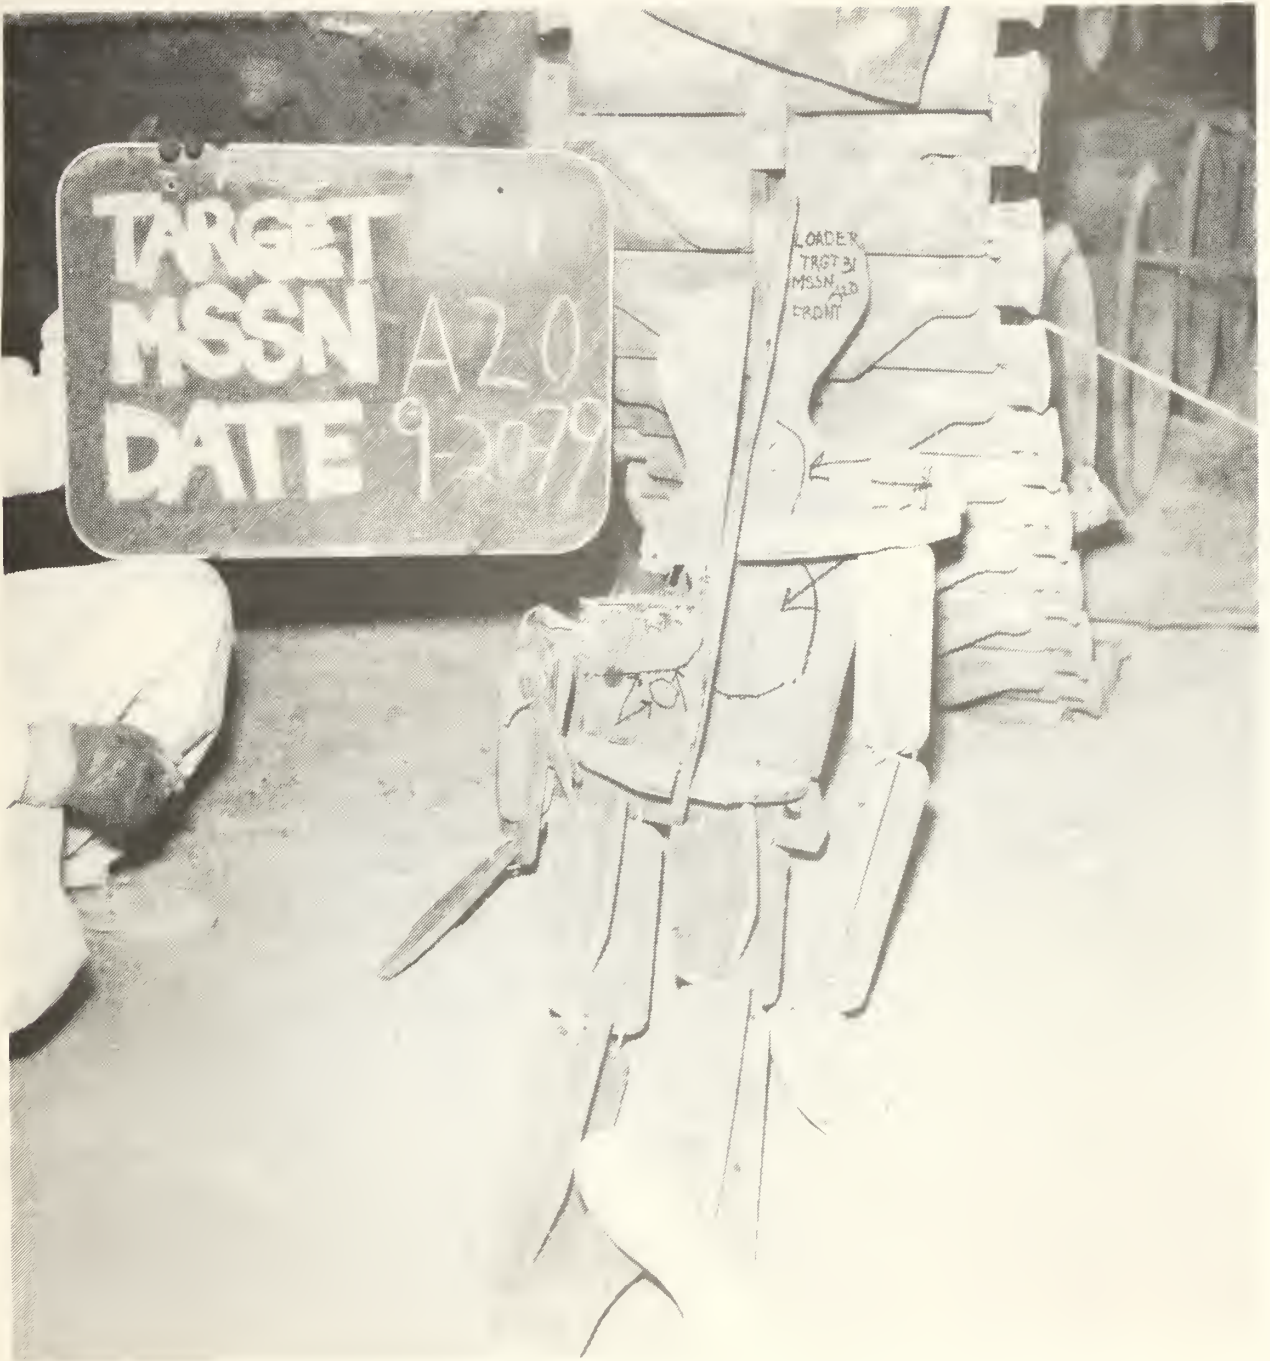
FIGURE 37. Damage to Loader Manikin caused by Impact 2, Tank 31.

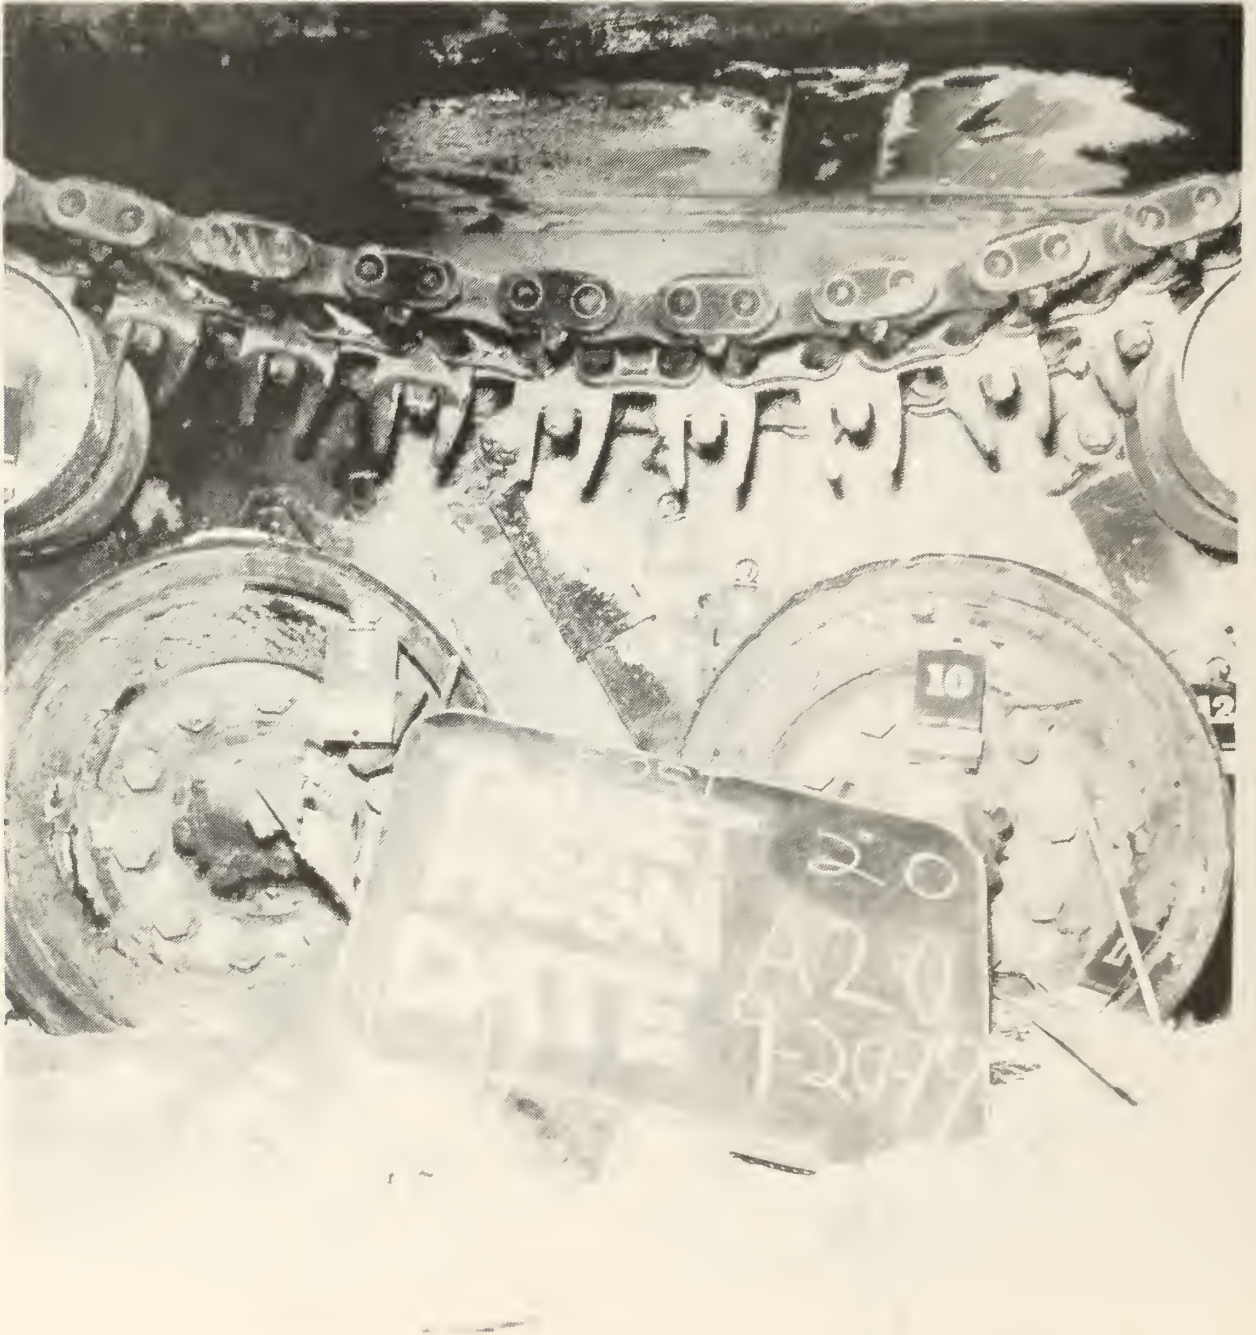
100% K-Kill due to a fuel fire resulting from impacts 8 and 9 (Figure 39) which perforated the left hull armor and penetrated the fuel tank and from impact 1 (Figure 40) which perforated the turret armor probably causing casualties to the commander, gunner, and loader.

FIGURE 39. Impacts 8 and 9 Penetrated the Fuel Tank, Providing Fuel for a Major Fire, Tank 20.
